# Report Index

101 FILE NAME: SAMPLE.  
 102 CLIENT NAME: Jane Client.  
 103 INSPECTION PROPERTY ADDRESS: 000 Any Street  
 Anytown, IL 60000.

110 ATTENDING: People present for a majority of the inspection: The individual licensed home inspector, and the client.  
 111 INSPECTED BY: Happy Home Inspection Services LLC  
 Entity License # 051.0000395 expires 11/30/40  
 Dale Bennett, Chief Inspector  
 Illinois License # 050.0001398 expires 11/30/04

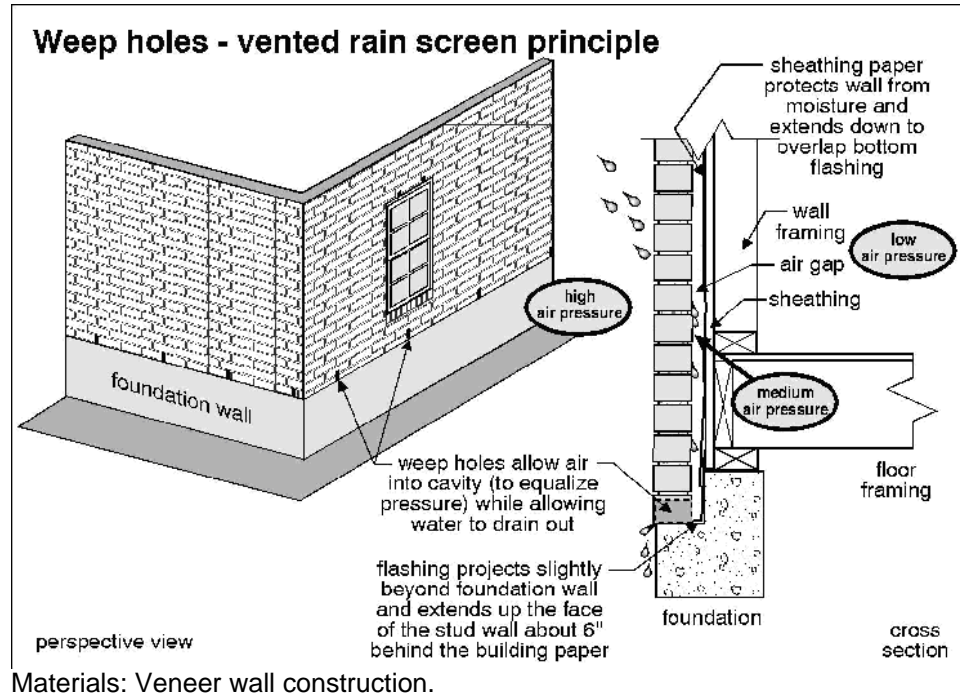
**307 MASONRY  
TYPE:**

Materials: Veneer wall construction.

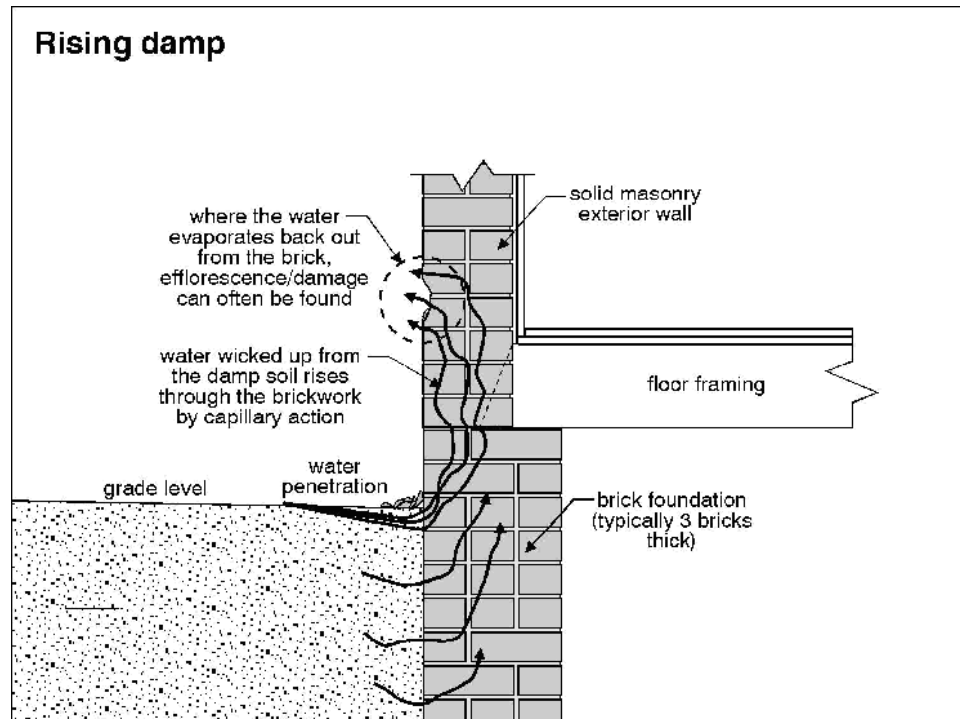
**309 MASONRY  
CONDITION:**

The brick walls appeared serviceable, with exceptions noted.

- a. [CR] There were no visible through-the-wall flashing(s) or weep holes installed at the foundation ledge, top of the door/window trim, around the concrete landing. This condition is conducive to moisture damage over time. We recommend correcting the condition(s) noted. [CR]
- b. Portions of the brick wall lacked adequate clearance from or were buried in the ground. These conditions are conducive to moisture intrusion/deterioration. We recommend regrading so that the water drains away from the home, and that a clearance of 8" is maintained between the siding and the grade.
- c. This condition was noted at the right side of the building - Small diagonal "step" cracks in the mortar.
- d. Small inverted "v" cracks over the main entrance, indicating some sagging in the lintel.

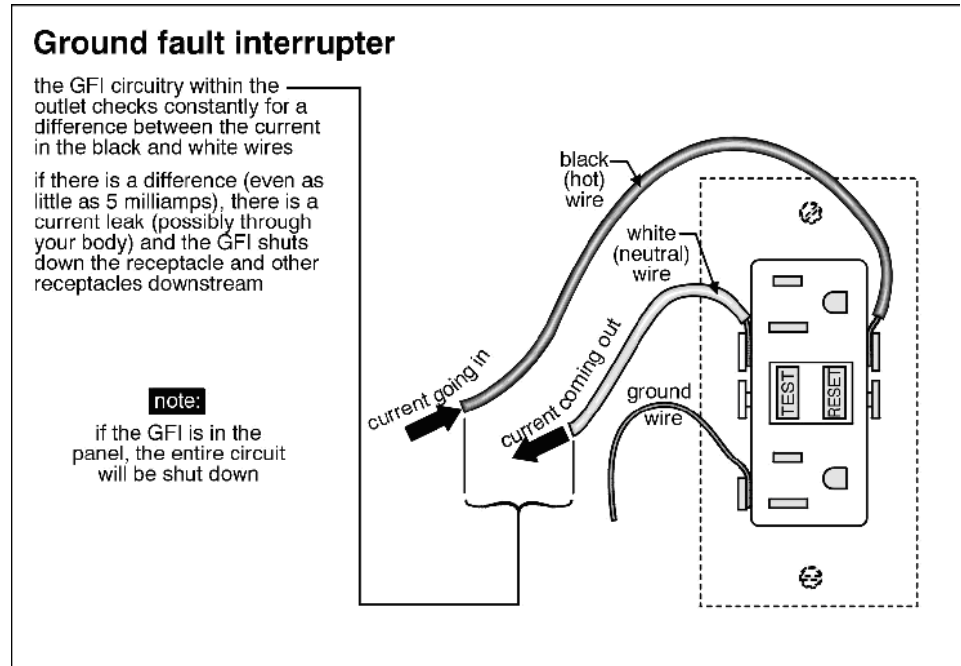
**805  
RECEPTACLES:**

The accessible receptacles were serviceable, with the following exceptions noted;

- a. [RU] The accessible receptacles were serviceable, they were not GFCI protected. We recommend upgrading to provide GFCI protection for the receptacles for safety reasons.

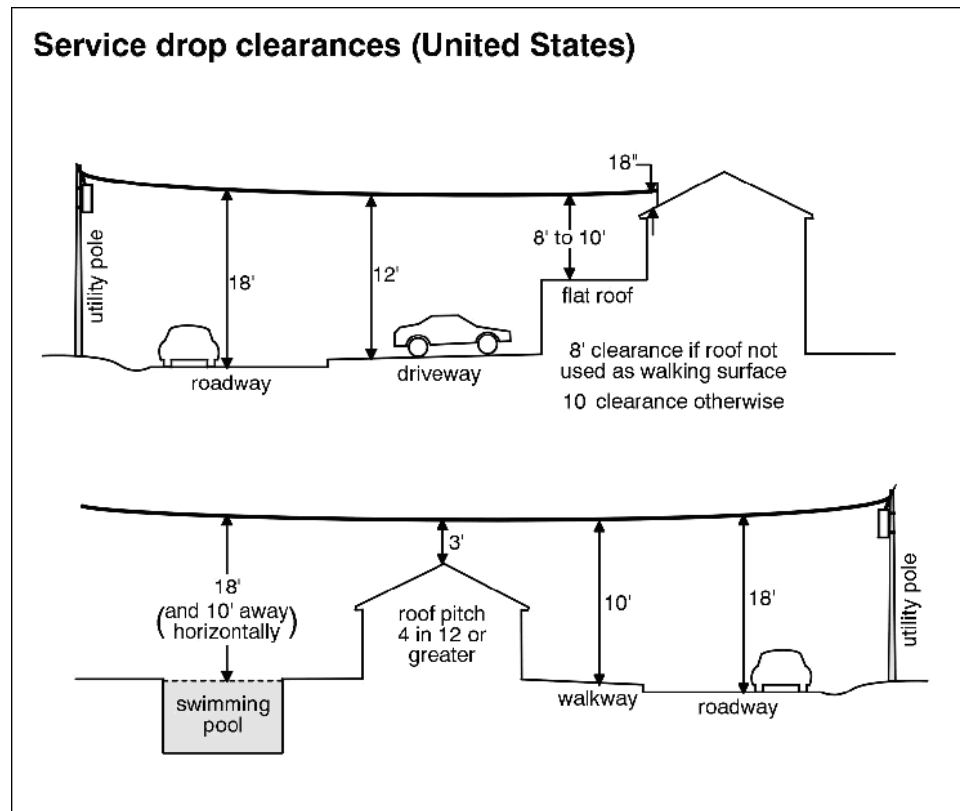
### 1708 SERVICE WIRING:

The service wiring appeared serviceable with the following exceptions noted;  
 a. [SC] The overhead service entrance cables were hung too low/too close to the deck.
