# Report Index

101 FILE NAME: SAMPLE.  
 102 CLIENT NAME: Jane Client.  
 103 INSPECTION PROPERTY ADDRESS: 000 Any Street  
 Anytown, IL 60000.

110 ATTENDING: People present for a majority of the inspection: The individual licensed home inspector, and the client.  
 111 INSPECTED BY: Happy Home Inspection Services LLC  
 Entity License # 051.0000395 expires 11/30/40  
 Dale Bennett, Chief Inspector  
 Illinois License # 050.0001398 expires 11/30/04

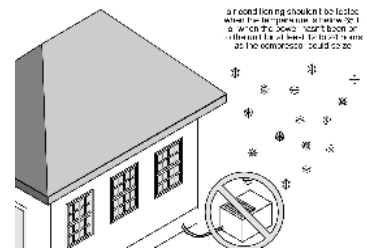
Don't test when it's cold

[FE] The outside air temperature was below 60 degrees. Operating the system under these conditions could damage the condensing unit compressor. We recommend having the system checked by a specialist in the appropriate trade when the outside air temperature has been above 65 degrees for a period of time.
